**PRELIMINARY ASSESSMENT
JEMEZ OPEN DUMP
SANDOVAL COUNTY, NEW MEXICO
CERCLIS ID # NM0000134007**

**PRELIMINARY ASSESSMENT
JEMEZ OPEN DUMP
SANDOVAL COUNTY, NEW MEXICO**

AUGUST 25, 1994

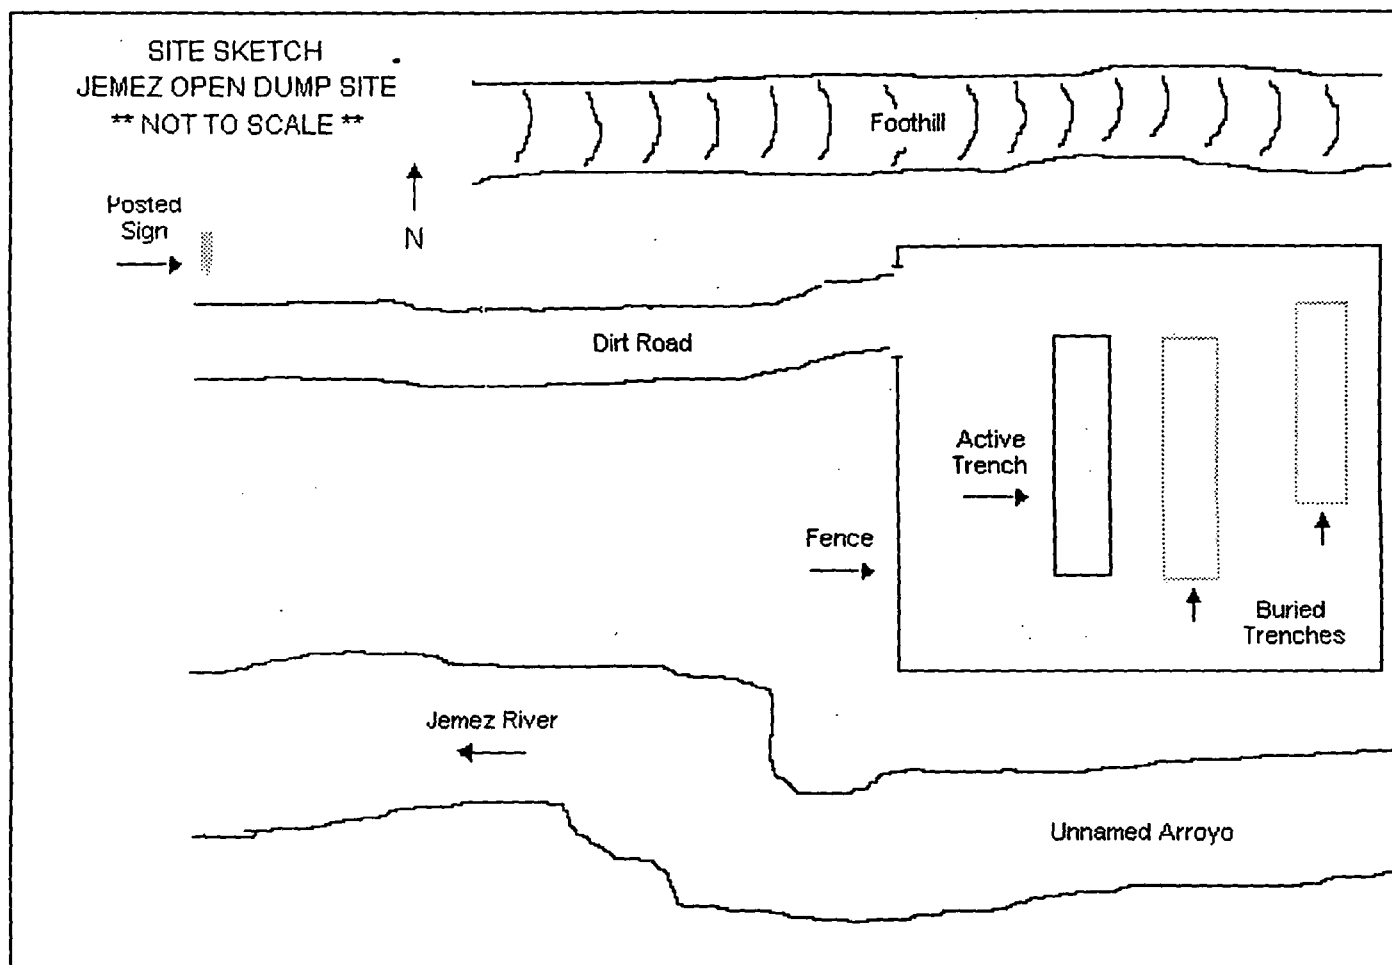
FIGURE 2.0: Site sketch of Jemez Open Dump distinguishing features on and near the site.
Note: Sketch is not to scale.

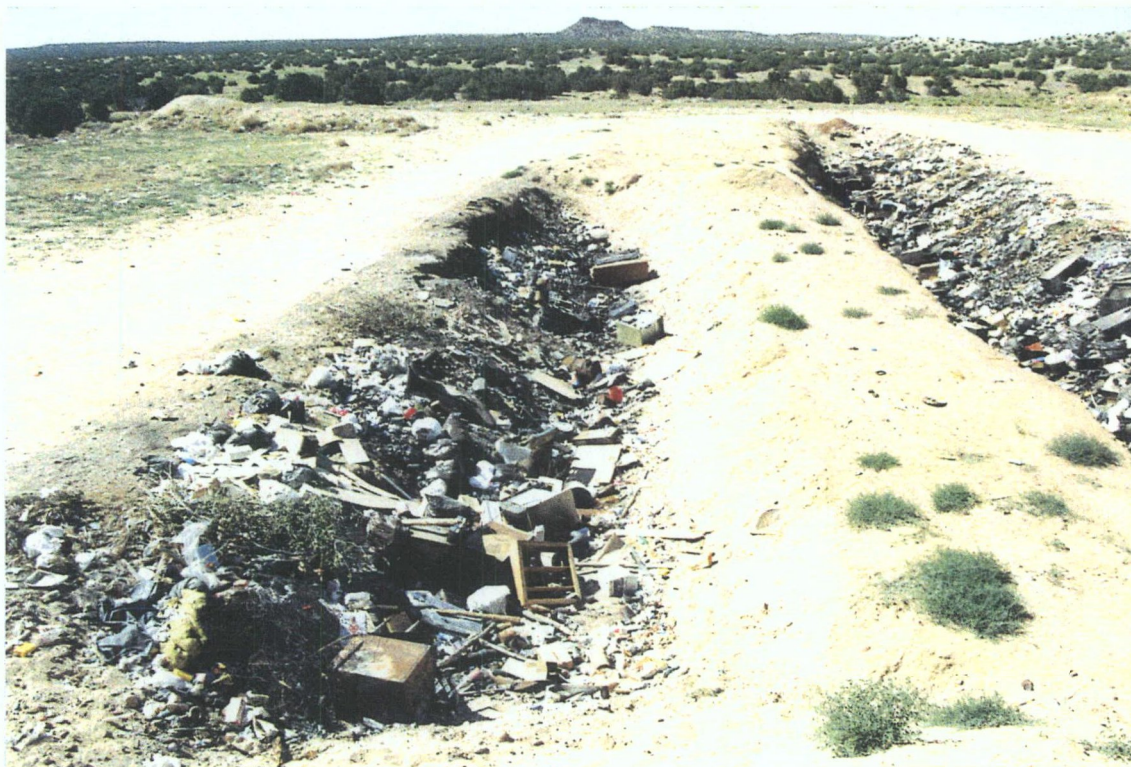
PHOTO 1.0

Description: Photo shows two active trenches. These trenches are trending east-west, they are unlined, and have no surface run-on or run-off controls. Also shows a buried trench at the eastern edge of the open dump site.

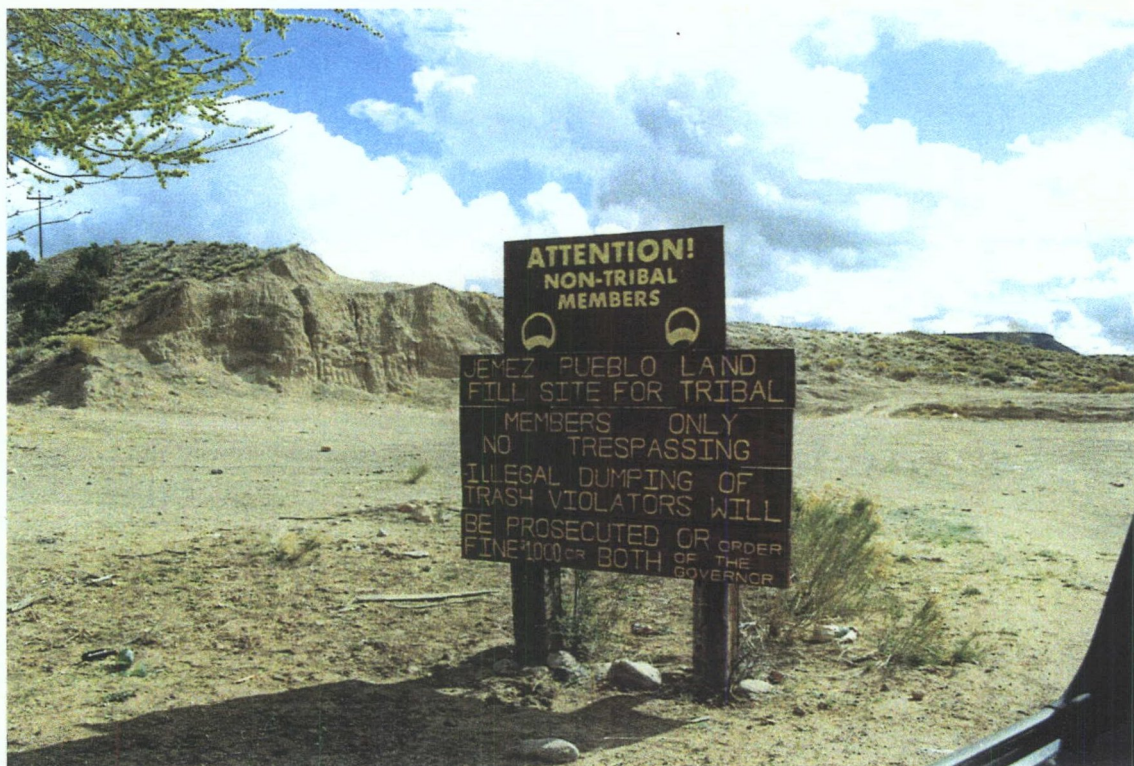
PHOTO 2.0

Description: Photo shows sign which is posted 0.5 mile west from the open dump site.

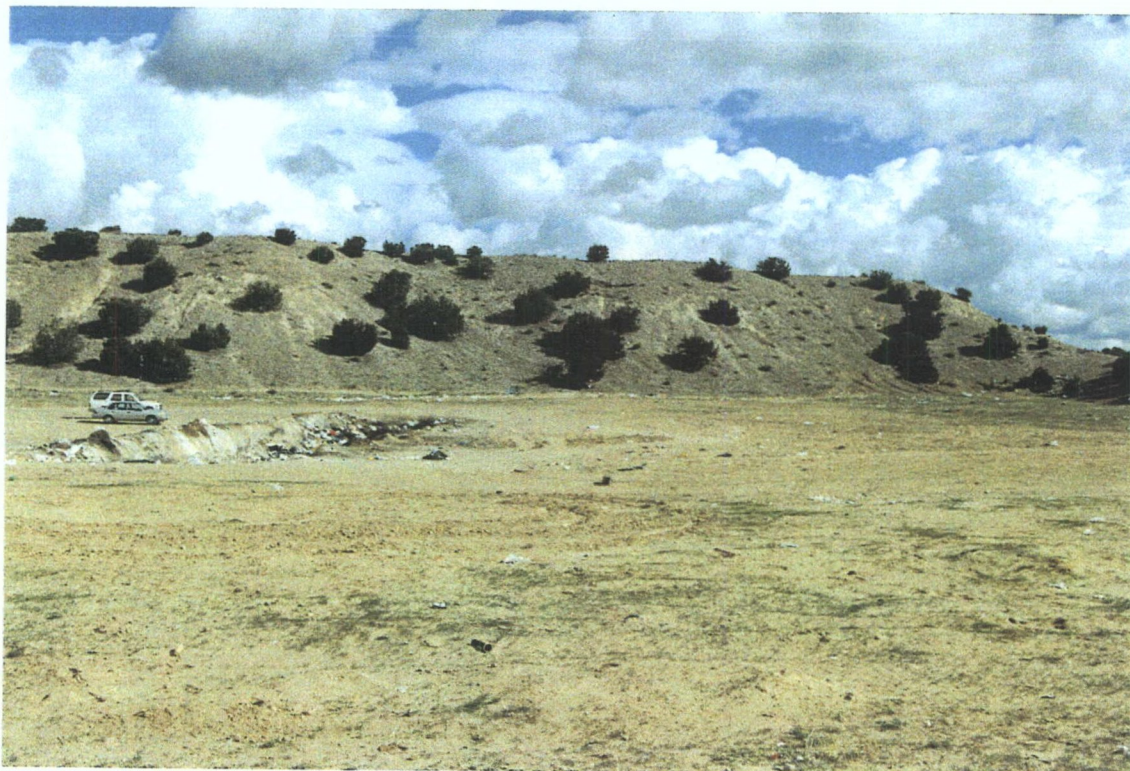
PHOTO 3.0

Description: Photo shows the open dump site. The active trench and two buried trenches.

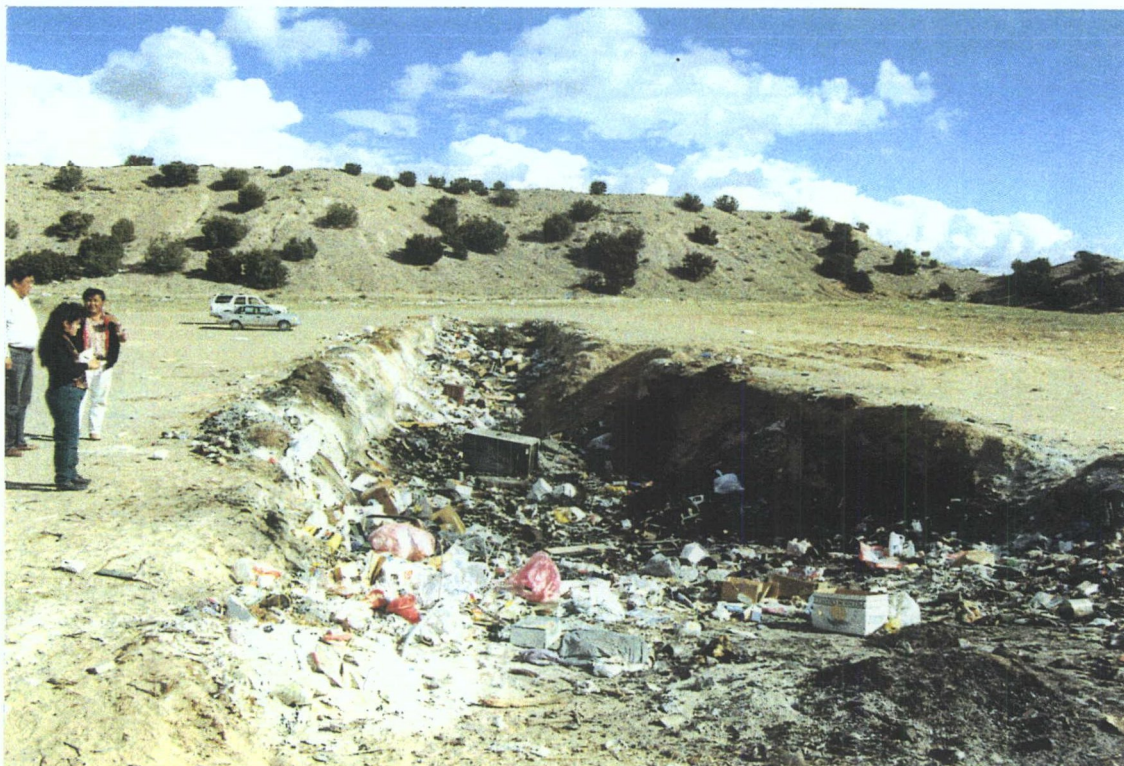
PHOTO 4.0

Description: Photo shows the active trench and various amounts of waste. There is evidence of previous burning activity and improper soil covering.

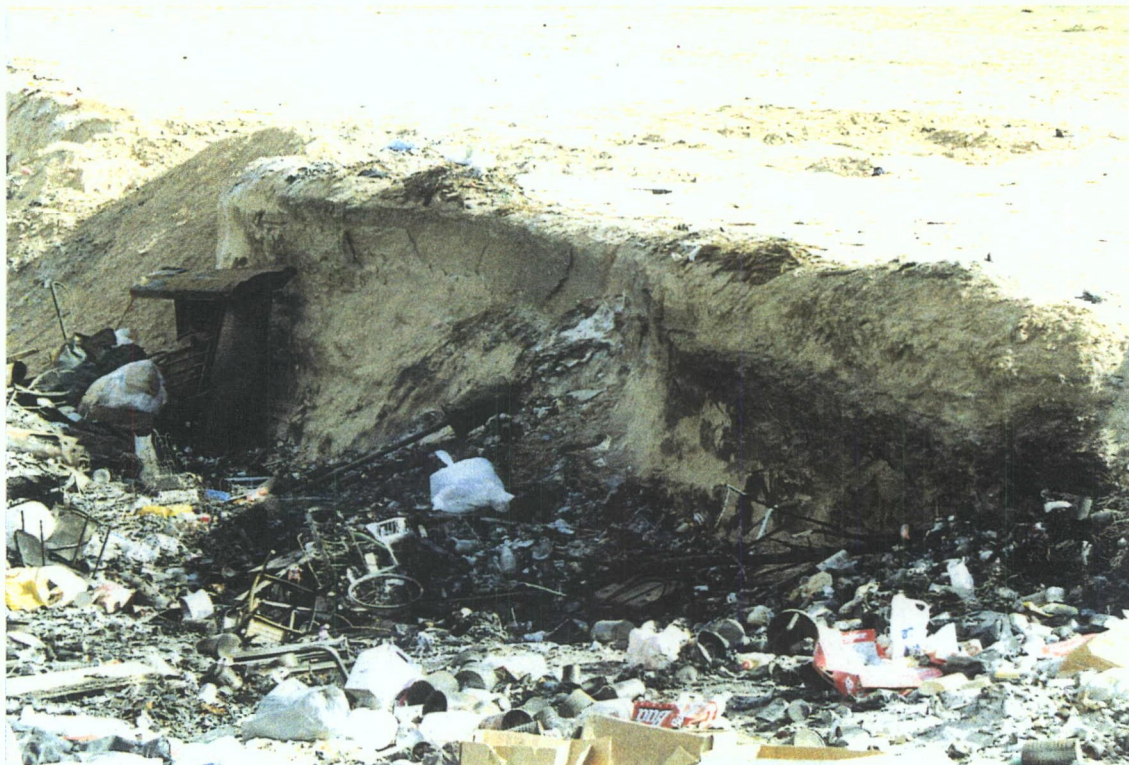
PHOTO 5.0

Observations made at the open dump provide evidence of burning of wastes in an open area (P.O.E.P. 1994, Photo 5.0). It is a common practice at the site to burn the waste in the trench (Loretto, 1994). The distance to the nearest residence is approximately 1.0 mile west of the site (P.O.E.P., 1994). The approximate number of people living relative to the site are shown in Table 2.0.

Description: Photo shows a portion of the active trench. There is evidence of no liner and release to air.

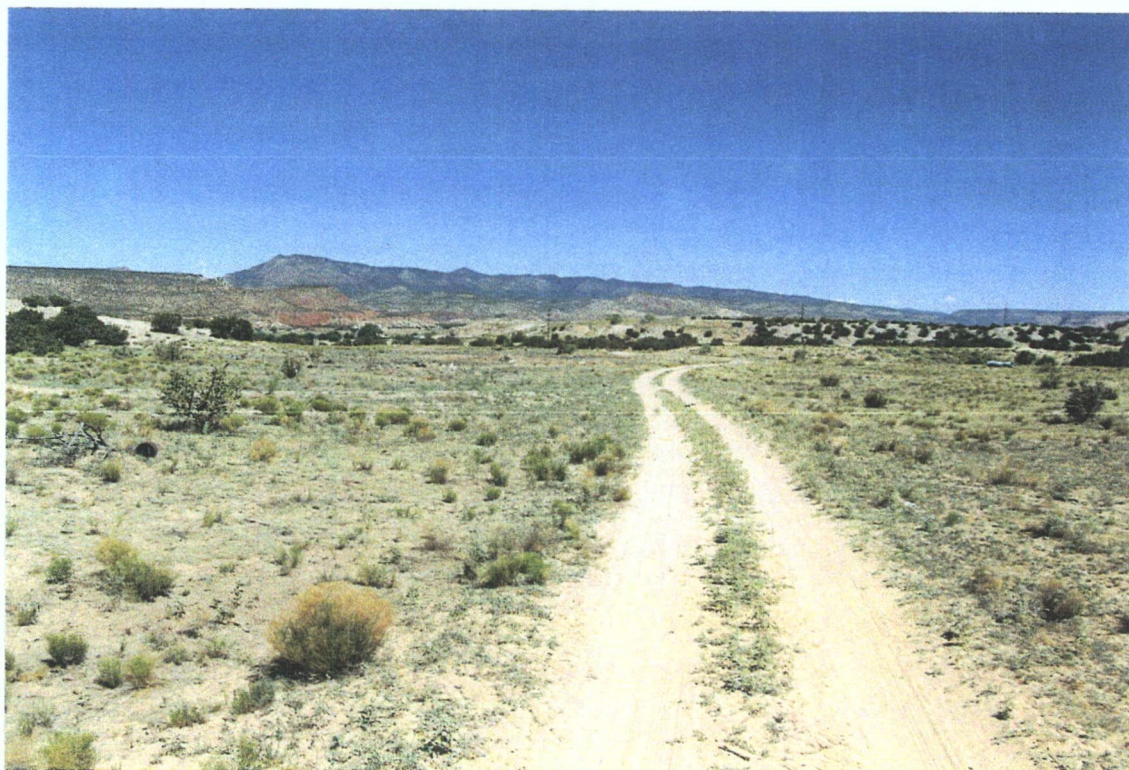
PHOTO 6.0

The Jemez Open Dump area is approximately 39 acres consisting of 10 acres of the active portion and the remaining 29 acres of surficial dumping (POEP, 1993, 1994; Photo 6.0). The surficial dumping are located approximately 500 feet west from the open dump site. These dump areas may have possibly been the old open dump area (POEP, 1993). The active portion consists of one active trench and two buried trenches (P.O.E.P., 1993; 1994; Figure 2.0). The perimeter of the site is fenced with no access restrictions. Access to the dump site is gained via a dirt road originating 1.0 mile west of the site. Upon entrance from State Road 4, there is a sign posted which restricts dumping from non-tribal members (POEP, 1994; Photo 2.0). The dump is located on a flat terrain that gently slopes in a southerly direction toward the unnamed arroyo. The unnamed arroyo is approximately 200 feet south of the site. This arroyo flows west toward the Jemez River located approximately 1.5 miles west of the site (Figure 1.0). Site reconnaissance observations also reveal that the primary surface vegetation at the site consist of range grasses and juniper trees (POEP, 1994). The nearest Pueblo residence is located approximately 1.0 mile west from the site (POEP, 1994; Gachupin, 1994).

Description: Photo shows several buried areas of dumping which are outside of the 10 acre active open dump site. These areas are located approximately 500 feet west of the active open dump site.
